## Four-Point Inspection Report

Date of inspection:	09-17-2009
Property's Address:	1234 NW 56 Ave
Property's City, State, Zip Code:	Miami, Florida 33333
Type of home:	Single Family Home
Type of construction:	Masonry and Concrete
Type of foundation:	Concrete
Number of stories:	One
Approximate square feet:	2139
Approximate total living area:	2139
Approximate age of home:	1974
Client/owner's name:	John Doe
Insurance company/policy number:	
Inspector's company name:	Atlantic Building Inspections
Inspector's phone number:	1-800-286-8983

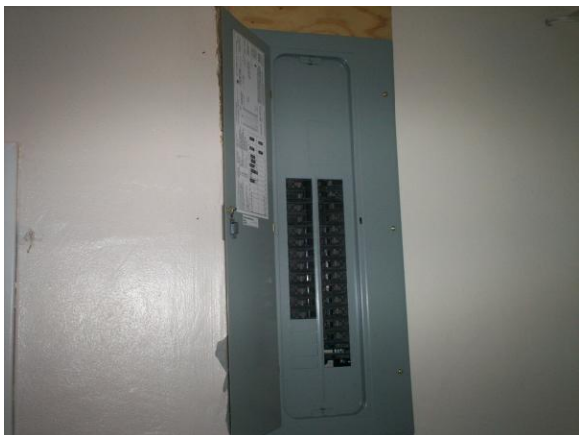
Electrical Panel

Service amps:	150
Size of service sufficient?	Yes
Fuses or Circuit breakers?	Breakers
Main panel location:	Exterior
Panel ground observed?	Yes
GFCIs present where required, by today's standards?	Kitchen: Yes   Bathrooms: No
AFCIs present in bedrooms?	No
Aluminum branch circuits?	No
Active knob and tube wiring?	No
Exposed or unsafe wiring noticed?	No
Recent upgrades? Year?	Yes 1990's and 2000's
Overall electrical system condition:	Good
Electrical comments:	None
